Maryland Development Company Pty Ltd
Sampling Analysis and Quality Plan

Central Precinct, Llandilo NSW

FINAL

12 November 2015
43352-57348 (Rev 4)
JBS&G

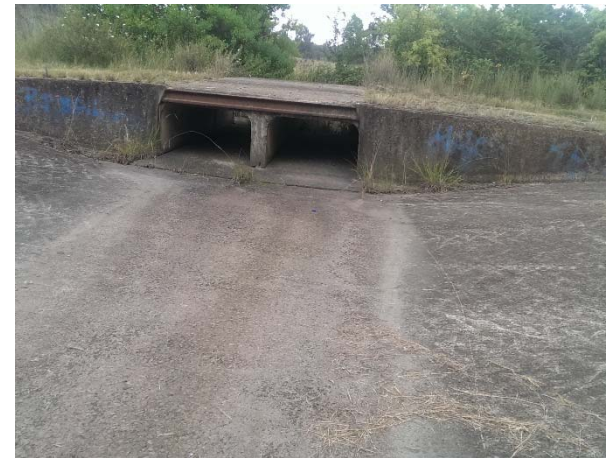
Photograph 6: Concrete culvert on drainage structure

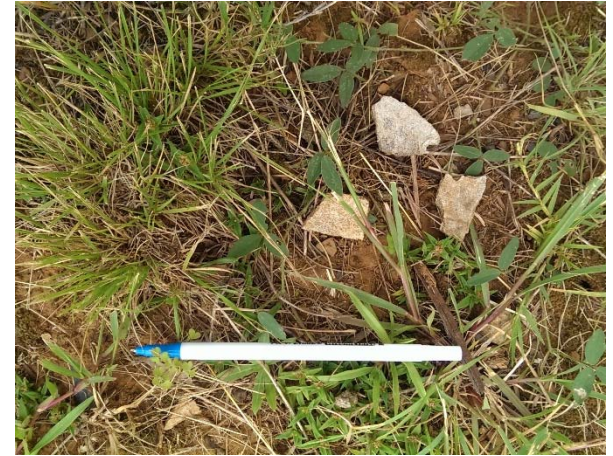
W02 (south) was a 2 storey structure with a deck on top that was also used as a radar room. The structure was made of concrete and galvanized steel with the room on lower level being used to store hay bales for recovering kangaroos. Steel steps and a ladder provided access to the rooftop deck. Suspected small ACM fragments were observed on the ground surface adjacent to the building (**Photograph 9, Appendix B**).

Photograph 9: Suspected ACM fragments observed next to 2 storey W02 structure

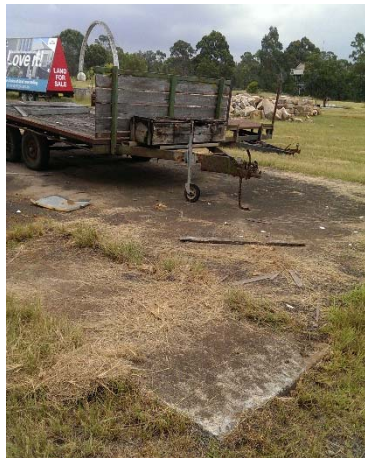
Photograph 10: Concrete slab (footprint of former W09 structure)

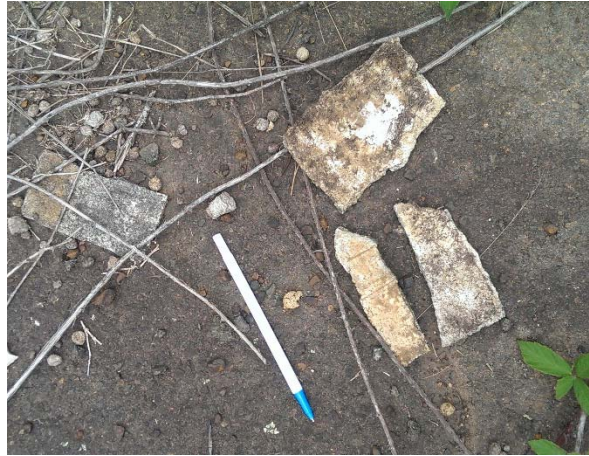
W05 area comprised the timber radar loop with steel cables (numbered as W04 on structure). Suspected highly weathered ACM fragments were observed on the paved area beside the radar loop (**Photograph 14, Appendix B**).

Photograph 14: Suspected weathered ACM fragments observed near radar loop

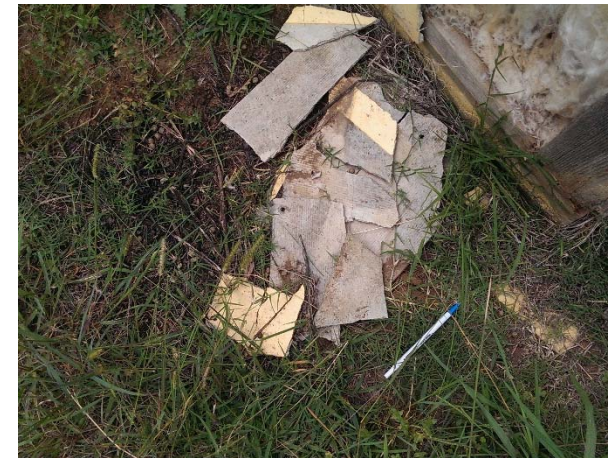
The toilet adjacent to W10 was made of ACM cladding that was damaged and suspected ACM fragments were observed on ground surface (**Photograph 18, Appendix B**).

Photograph 18: Suspected ACM fragments observed near toilet

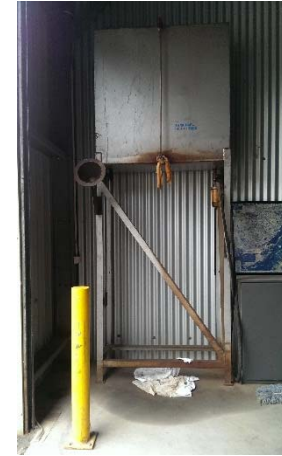
W11 was a large colour-bond steel warehouse which was on a slightly elevated surface with surrounding land sloping toward the east. The left portion housed Kangaroo Management Offices while the middle portion was used as a car storage/park. The right portion was being used as storage/workshop space. A 500 Litre diesel storage tank with no bund was identified and some staining on the ground surface was observed (**Photograph 21, Appendix B**).

Photograph 21: 500 L diesel tank with some staining observed on the floor

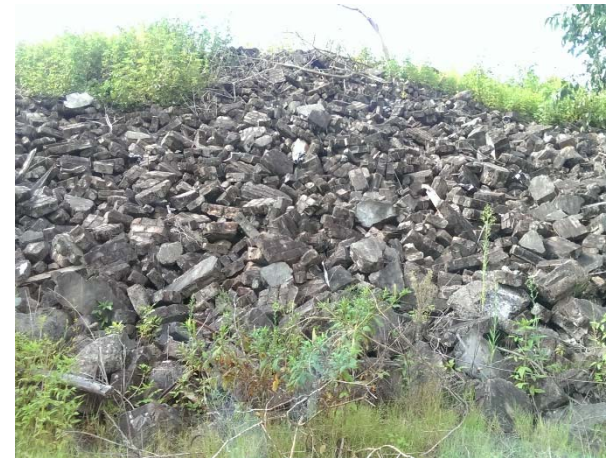
Photograph 42: Stockpile 36 comprising brick
