Maryland Development Corporation
Conceptual Remedial Strategy

Stages 3 to 5
Central precinct
Llandilo, NSW

FINAL
29 April 2015
50539-100238 (Rev 0)
JBS&G

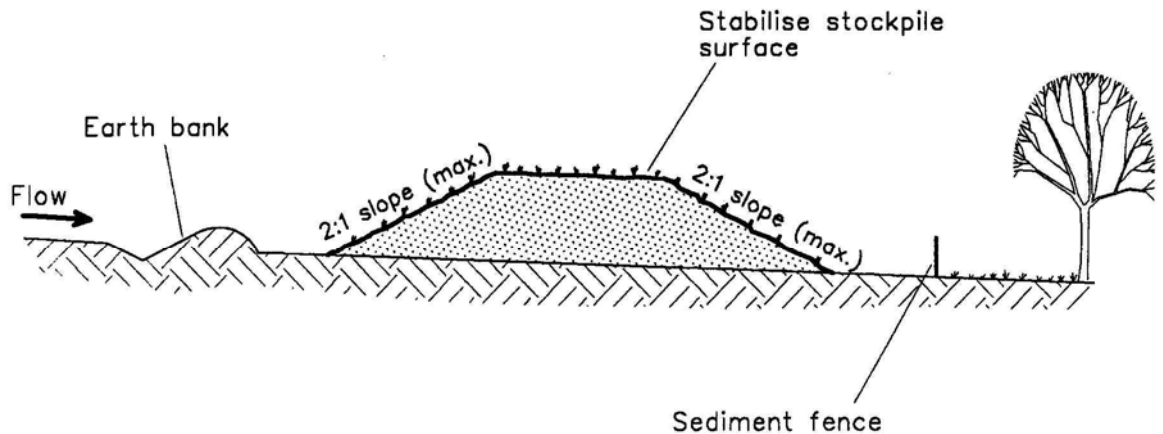
Construction Notes

1. Locate stockpile at least 5 metres from existing vegetation, concentrated water flows, roads and hazard areas.
2. Construct on the contour as a low, flat, elongated mound.
3. Where there is sufficient area topsoil stockpiles shall be less than 2 metres in height.
4. Rehabilitate in accordance with the SWMP/ESCP.
5. Construct earth bank (Standard Drawing 5-2) on the upslope side to divert run off around the stockpile and a sediment fence (Standard Drawing 6-7) 1 to 2 metres downslope of stockpile.
