Maryland Development Company Pty Ltd
Contamination Management Plan

Central Precinct, Llandilo NSW

5 March 2015
43352/61064 (Rev B)
JBS&G

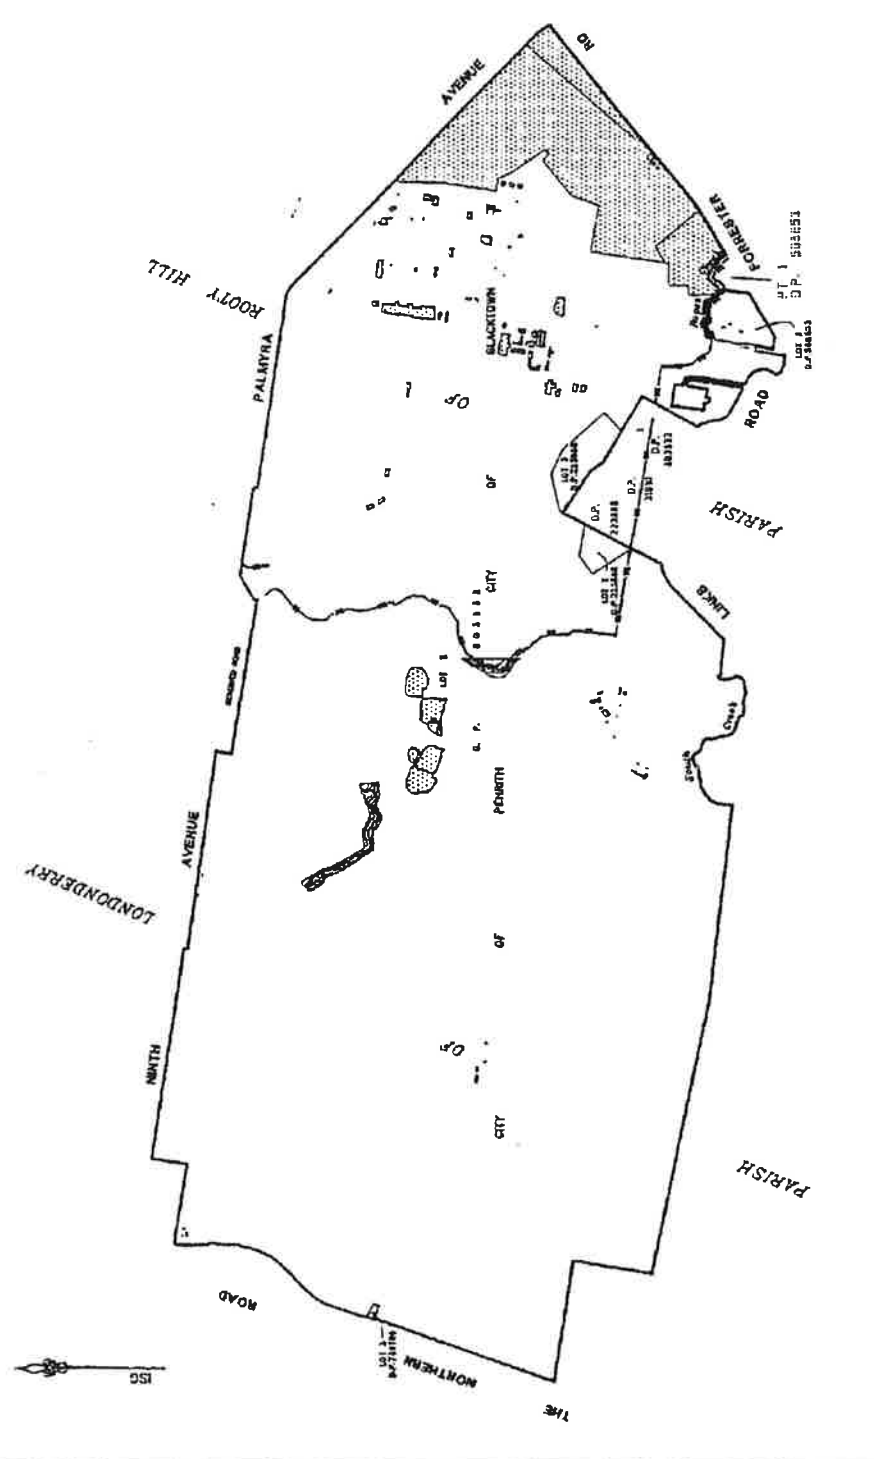
ADI ST MARYS PROPERTY
 PLAN TO ACCOMPANY SITE
 AUDIT STATEMENT CHK001/1

NOTE:
 GEOMETRY SHOWN AS SUPPLIED BY AN UNLIMITED TO OWN
 OFFICE 10.5.1989
 FOR SITE DETAILS ON EXCLUDED AREAS PLEASE REFER TO
 DRAWINGS:
 5467-123
 5467-125
 5467-126
 5467-127
 5467-128
 5467-129
 5467-130
 5467-131
 5467-132
 5467-133
 5467-134
 5467-135

SHADED AREAS ARE EXCLUDED FROM
 AUDIT STATEMENT CHK001/1

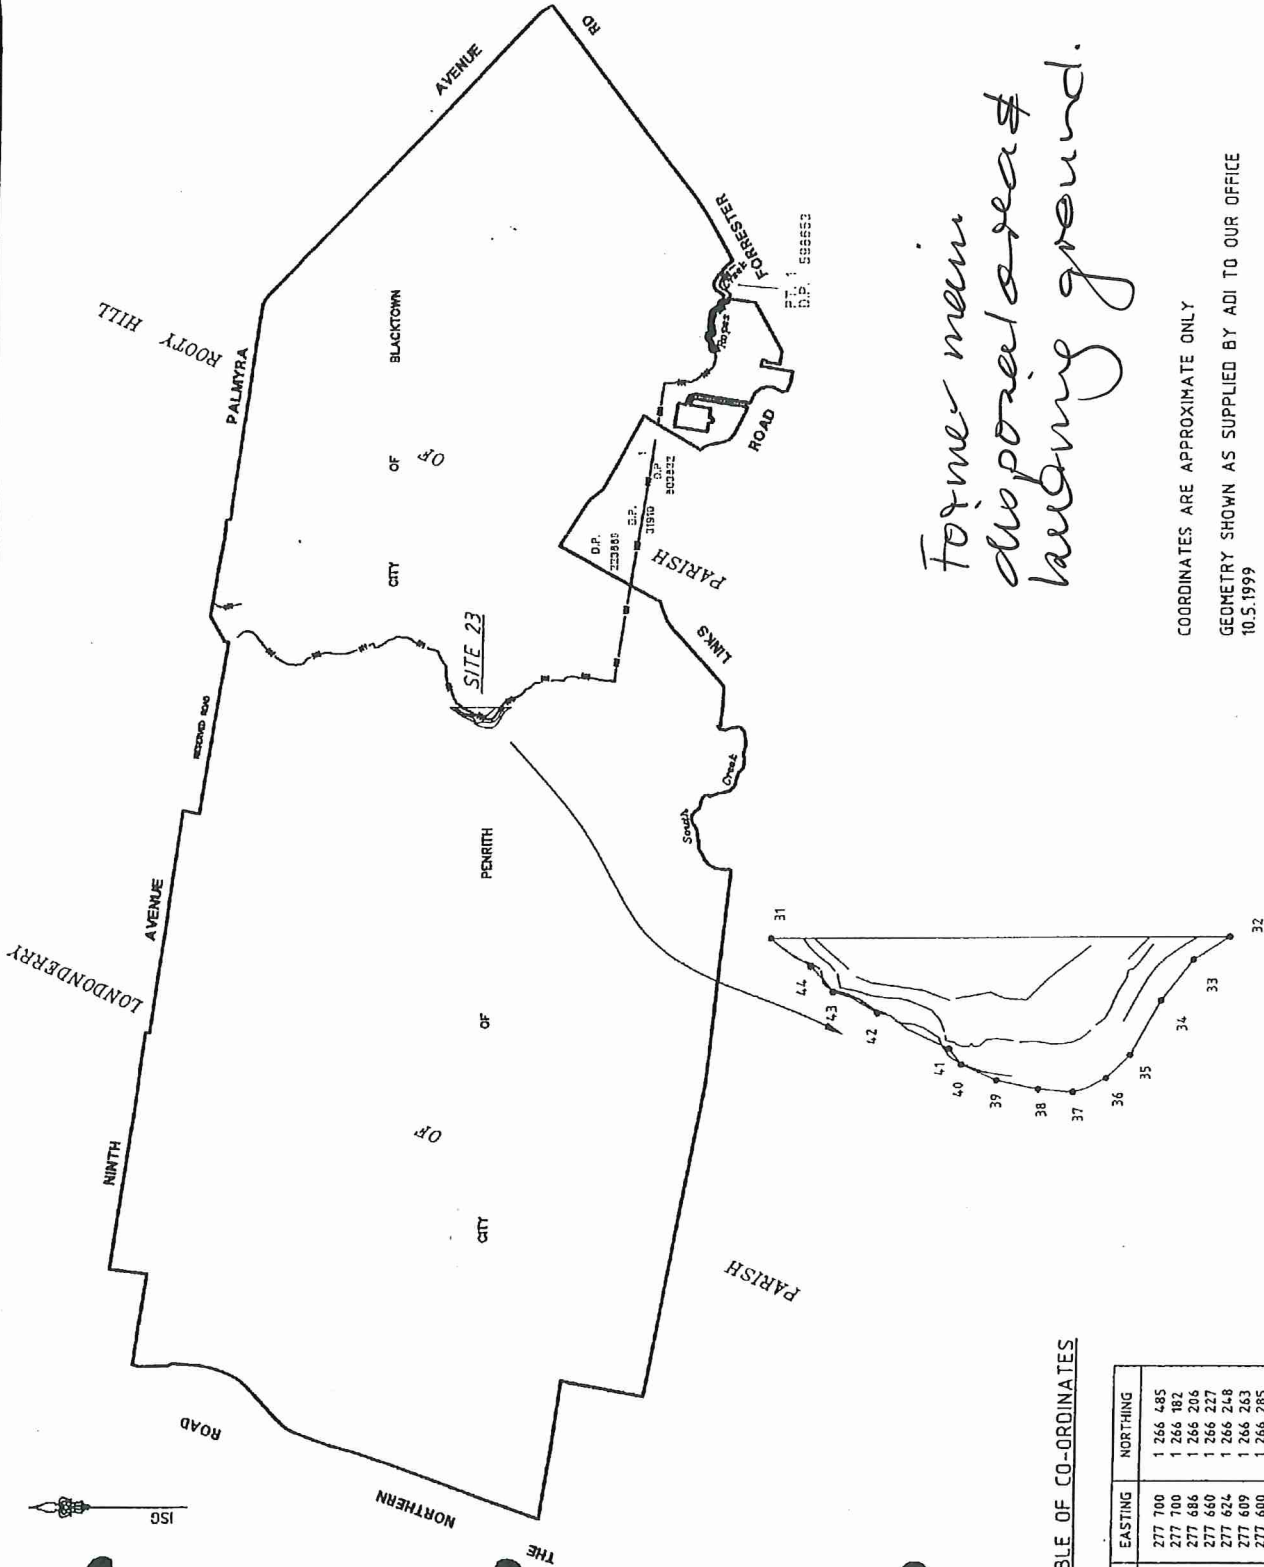
*Former main
dipping area &
landfill ground.*

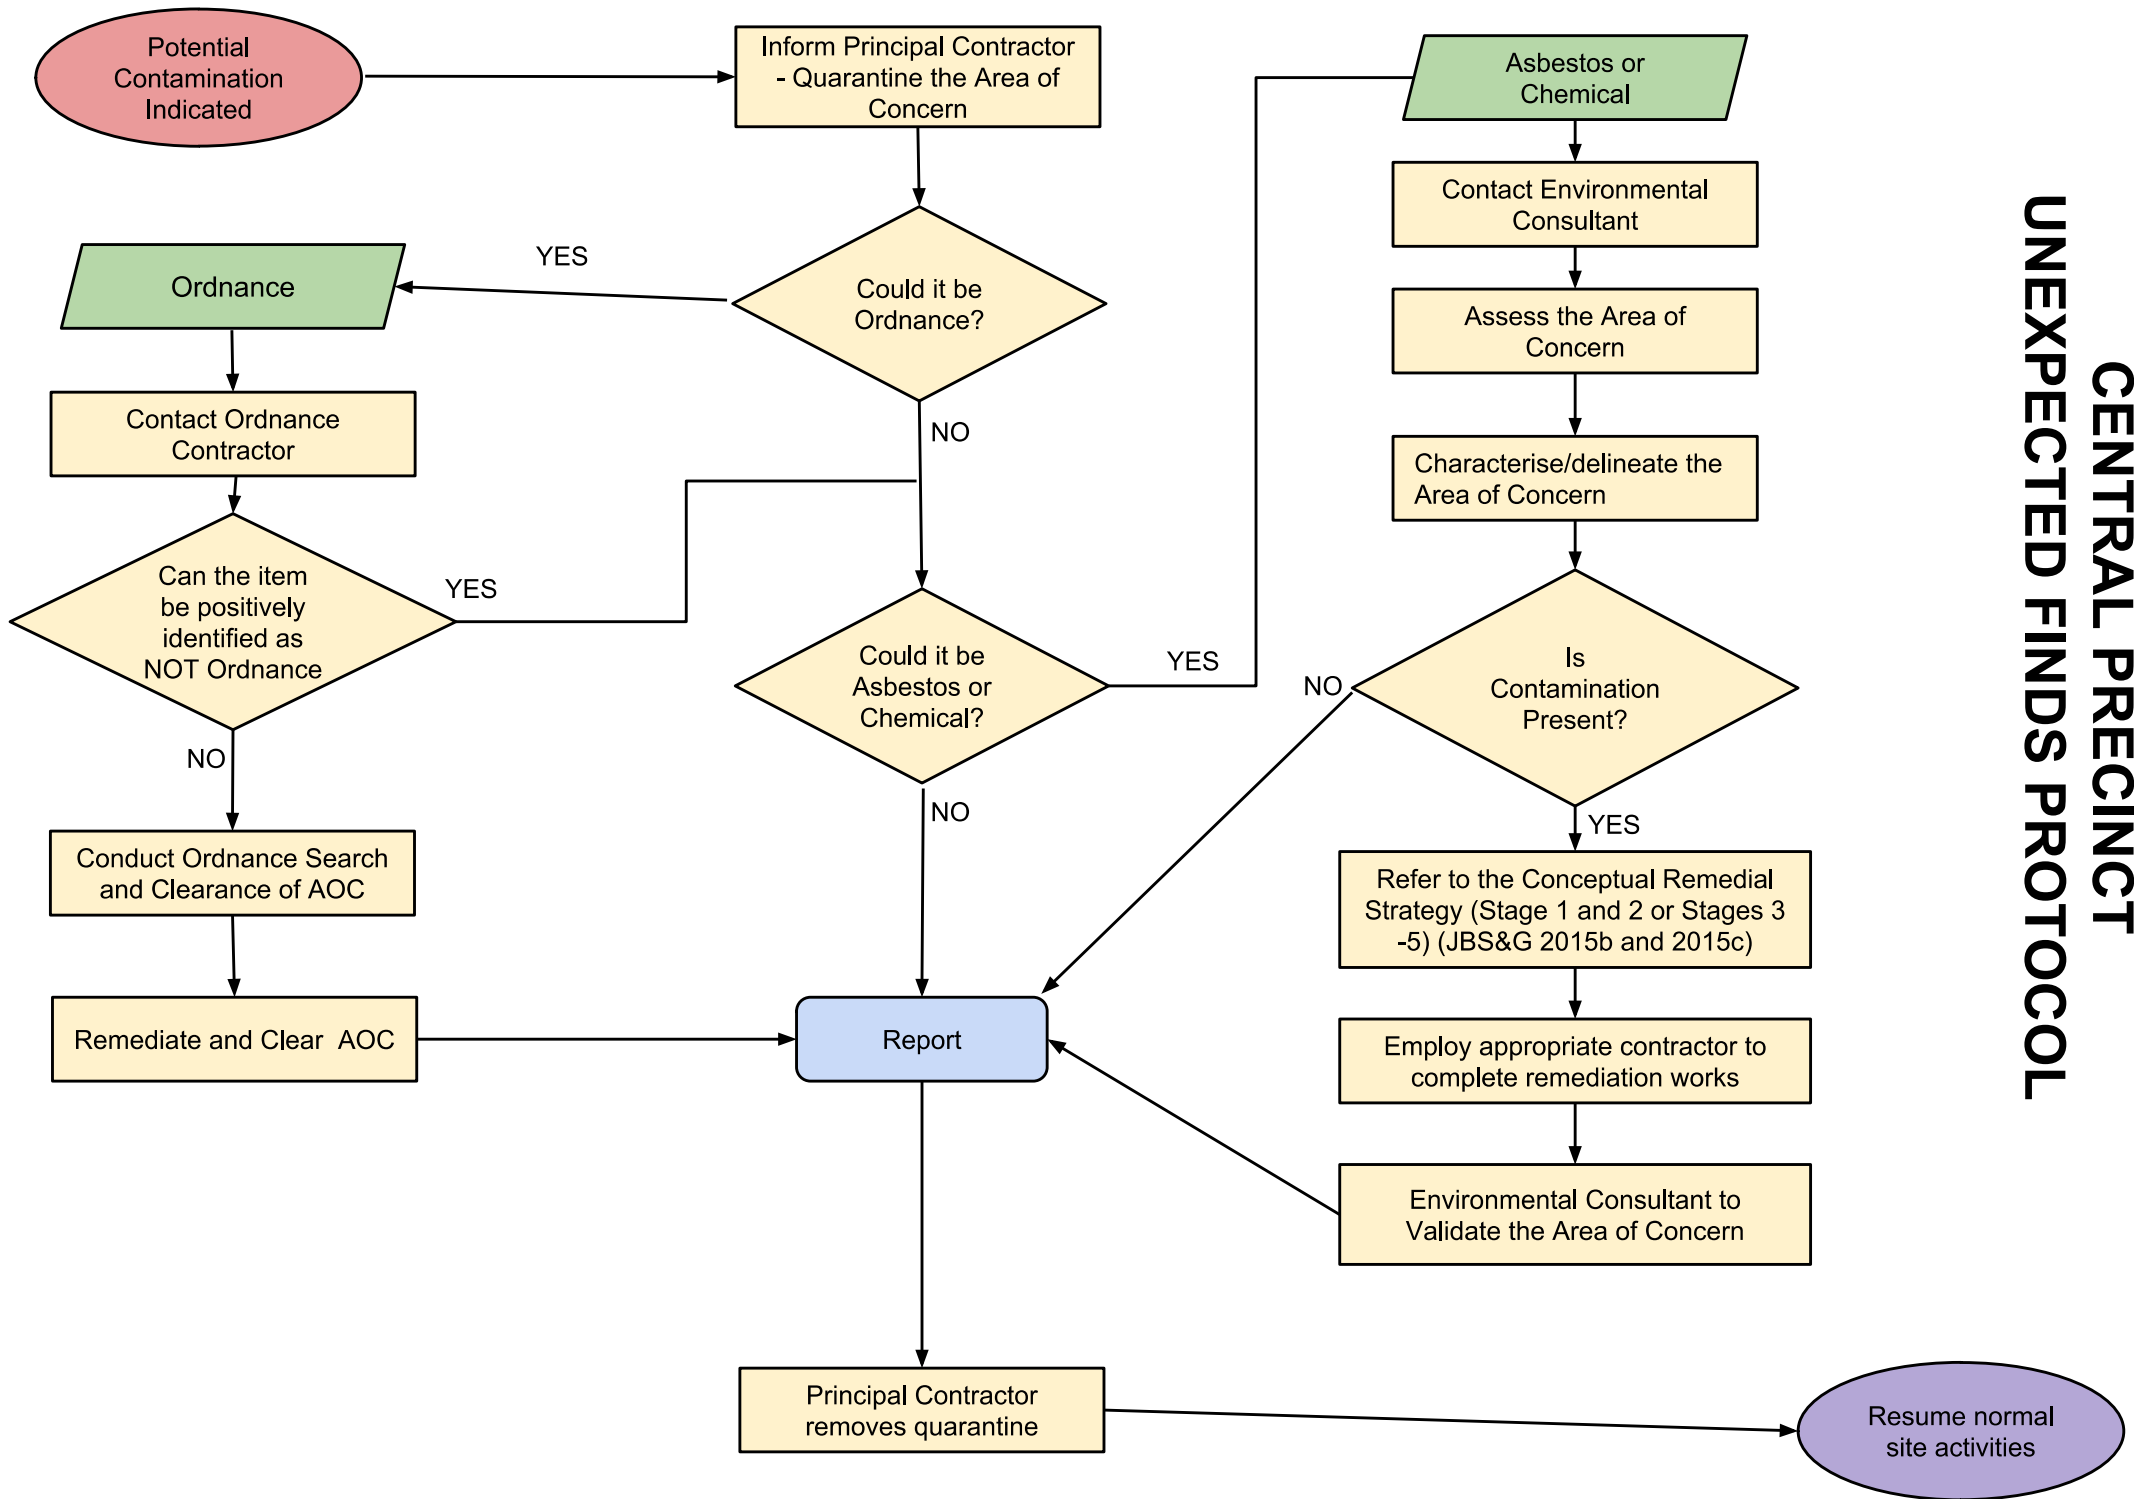
CENTRAL PRECINCT UNEXPECTED FINDS PROTOCOL

BE AWARE UNEXPECTED HAZARDS MAY BE PRESENT

do not restart working before the area has
been investigated and cleared by an
Environmental Consultant
